# Dubrovnik's Old City:

## The Destruction of a World Heritage Cultural Site

*UNESCO, the Institute for the Protection of the Cultural Monuments and Natural Environment of Dubrovnik, and the Institute for the Rehabilitation of Dubrovnik*

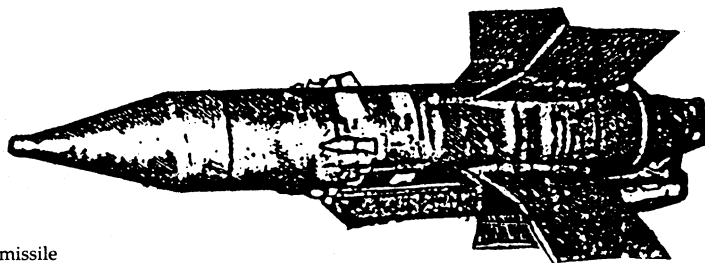
Until civil war broke out in the former republics of Yugoslavia, no army had ever attacked the Old City. In October 1991 it fell victim. Between then and June 1992, it was hit by over 2,000 shells of various types (Figure 2). Some 68% of the 824 buildings in the Old City sustained damage. Four hundred thirty-eight roofs took direct hits and 262 more were struck by fragments of projectiles. Some 314 direct hits were recorded on the fronts of buildings and on the paving of streets and squares. Fire gutted nine buildings and partly destroyed the roofs of four others

Figure 2. Type of projectiles used on Dubrovnik. Drawings: Matko Vetma and Zvonimir Franic (Institute for the Protection of the Cultural Monuments and Natural Environment of Dubrovnik).

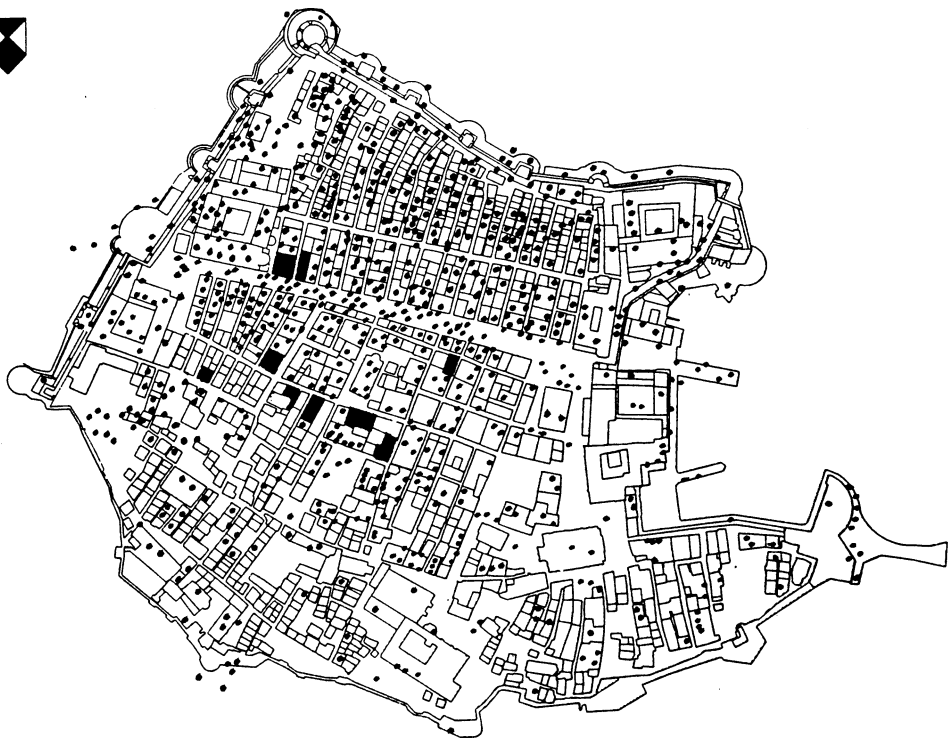
(Figure 3). Over 50 cultural monuments outside the Old City were damaged, as well as many modern buildings.

Figure 3. Diagram of Dubrovnik's Old City. Each black dot represents a direct hit by artillery. Solid black sections represent totally gutted buildings. Adapted from an illustration by the Institute for the Protection of the Cultural Monuments and Natural Environment of Dubrovnik.

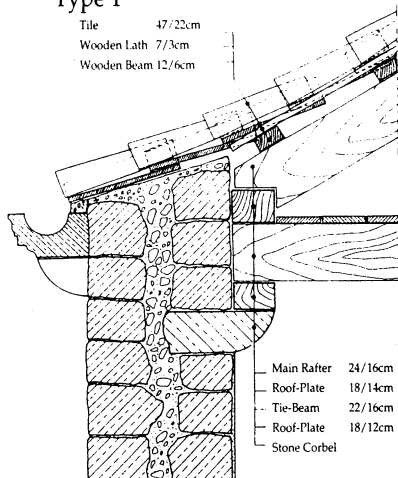
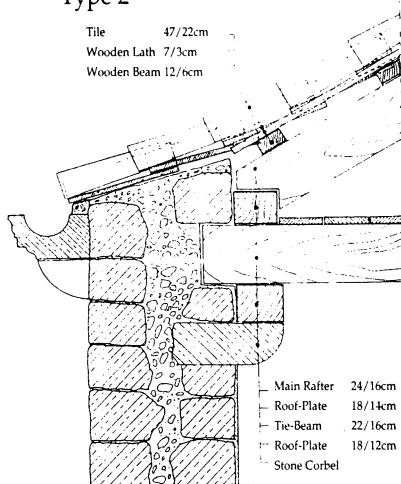
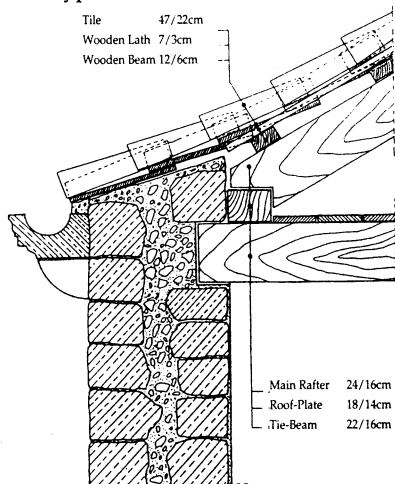
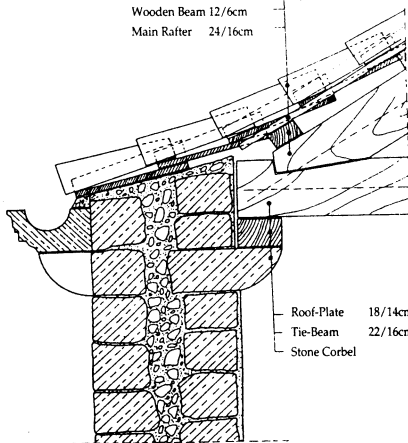
Around 69% of the rooftops were damaged by direct hits or shell fragments, most of which exploded on impact, causing, in addition to the explosion itself, the violent projection of a multitude of fragments. More often than not this resulted in a gaping hole,

usually about a meter square, in the roof, with many tiles broken and roof-strips destroyed. In some instances, structural components of the roof timbers were destroyed, stone eaves ruptured, and ceilings collapsed.

Figure 4. Example of artitechural detail in four approaches to the guttering sections, showing stonework and roof support methods. Drawings: Matko Vetma and Zvonimir Franic (*Institute for the Protection of the Cultural Monuments and Natural Environment of Dubrovnik*).

After each episode of shelling, local inhabitants, with help from the Institute for the Protection of Cultural Monuments and the Institute for the Rehabilitation of Dubrovnik, set to work making repairs. Bituminous roofing was laid on a provisional structure of thin planks where roof-strips had been destroyed. Where possible, tiles were replaced temporarily.

Permanent repairs will take much longer. UNESCO estimates that some 490,000 tiles will need to be replaced. The quarries that supplied the traditional *kupa* tiles are now worked out, so similar tile will be imported from France until a Croatian tile-works can be re-established.
