Saving the Bar BC Dude Ranch: A New Method for Setting Preservation Priorities

Frank Matero

The George Wright Forum, vol. 33, no. 1, pp. 47–58 (2016).

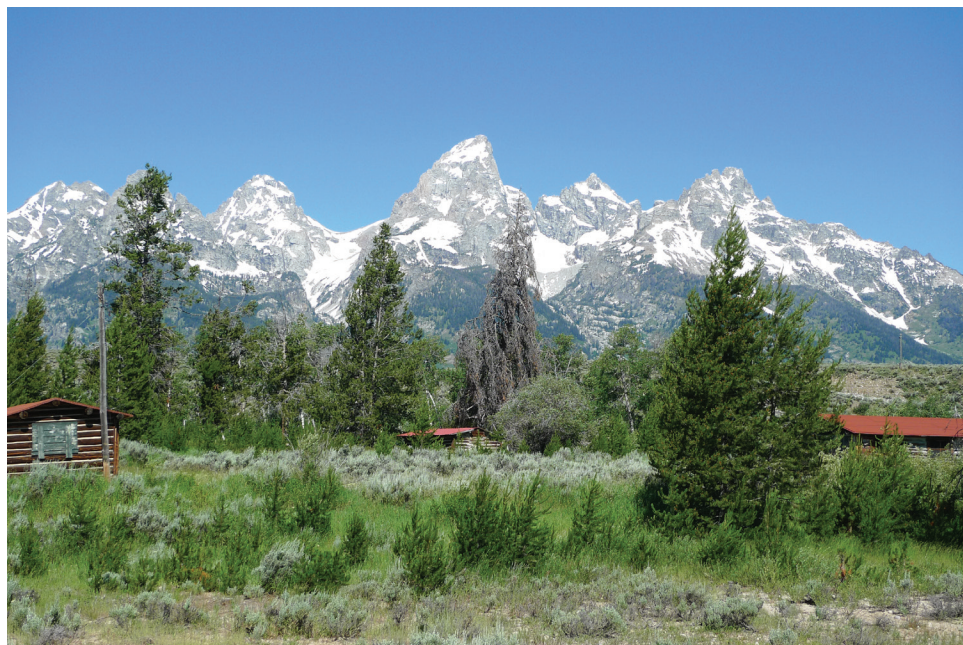
Figure 2. Bar BC Dude Ranch, 2015. Current condition of overgrown landscape and ruined buildings. (Photo courtesy of the Architectural Conservation Laboratory/University of Pennsylvania.)

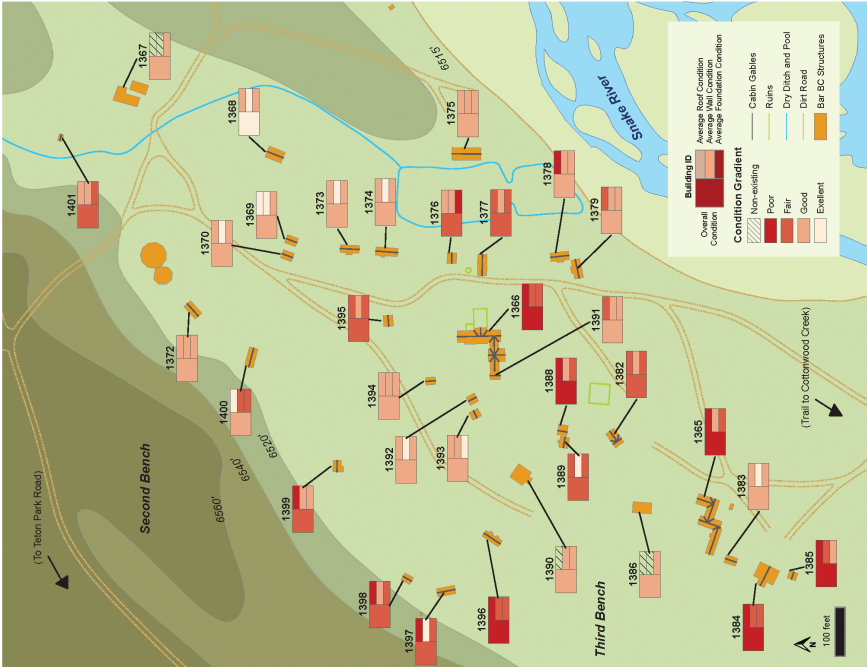
The information generated in the survey was entered into a Microsoft Access database, which allowed the data to be analyzed quantitatively. The data were then queried to suggest relationships between the condition of the building and site characteristics such as orientation, as well as comparisons between architectural elements within a single building or across multiple examples. The creation of a “ranked” list of buildings by condition and/or integrity was created to help prioritize stabilization and preservation work on the structures as funds and assistance become available. In order to visualize the data, the Access database was linked to a GIS, producing a site plan complete with symbol-coded values for the condition of individual elements as well as an entire building (Figure 4).

Figure 4 (opposite). Bar BC Condition Assessment. Overall conditions site map, 2012. (Photo courtesy of the Architectural Conservation Laboratory, University of Pennsylvania.)
