This PDF file is a digital version of a chapter in the 2005 GWS Conference Proceedings. Please cite as follows:

Riparian System Recovery after Removal of Livestock from Santa Rosa Island, Channel Islands National Park, California

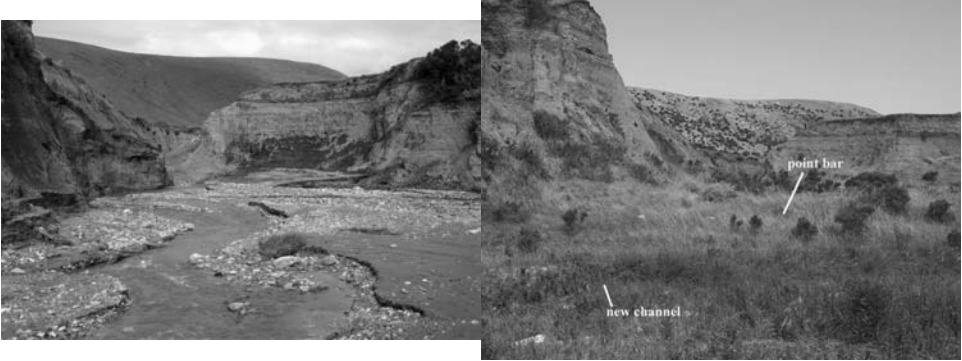
Of the stream reaches that recovered from “nonfunctional” to PFC, Arlington Canyon (Reach #5) had the most dramatic geomorphic and vegetative response (see repeat photography in Figure 1). The 1995 grazing-era photo shows a stream that is missing almost all of the components required for a properly functioning riparian system. An oversupply of sedi-

ment from upland and channel sources had exceeded the stream's transport capability, resulting in a mostly braided channel form, high lateral instability, high width-to-depth ratios, and other characteristics that were out of balance with the landscape setting. Riparian-wetland vegetation was absent, exposing banks to excessive erosion in each flood event. By 2004, this stream reach had recovered to a narrower, deeper, meandering channel with a well-developed floodplain and a gradient that is in balance with the landscape setting. Recovery of chaparral and riparian vegetation has apparently reduced excess runoff and erosion to the point where the stream is now in balance with the water and sediment being supplied by the watershed. Point bar development along the new meandering channel is one of the most striking geomorphic changes. For example, the large point bar at the center of the 2004 photo in Figure 1, which rises several feet above the current channel, did not exist in 1995.

Figure 1. Arlington Canyon, 1995 (left) and 2004 (right). Recovery of vegetation, reduction of erosion, and point bar development between 1995 and 2004 resulted in a meandering stream channel in balance with the water and sediment being supplied by the watershed.

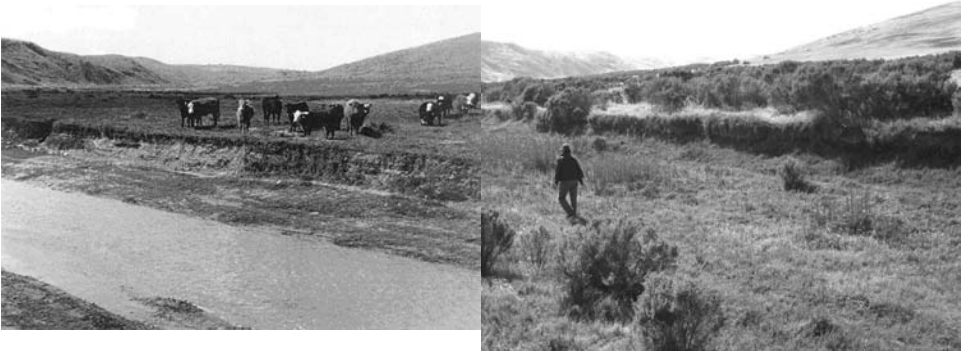
Old Ranch Canyon (Reach #9) provides a second example of recovery from a "non-functional" condition during year-round grazing (1995) to PFC after removal of cattle and reductions in deer and elk populations (2004). The 1995 photo in Figure 2 shows the poor stream/riparian conditions that existed in 1995 (high width-to-depth ratios, unvegetated and eroding bars and channel banks, low sinuosity). By 2004, about 30% of this reach had developed narrower, meandering channel forms and well-vegetated channel banks and floodplains within the old incised channel. The rest of the reach recovered to a properly functioning system characterized by vegetated swales with nearly 100% cover within the older incised banks in most areas.

Figure 2. Old Ranch Canyon, 1995 (left) and 2004 (right). Cover and height of the native shrub coyote brush (*Baccharis pilularis*) increased considerably between 1995 and 2004.
