This PDF file is a digital version of a chapter in the 2005 GWS Conference Proceedings. Please cite as follows:

Big Egg Marsh Experimental Restoration in Jamaica Bay, New York

George W. Frame, Division of Natural Resources, Gateway National Recreation Area, 210 New York Avenue, Staten Island, New York 10305-5019; george_frame@nps.gov

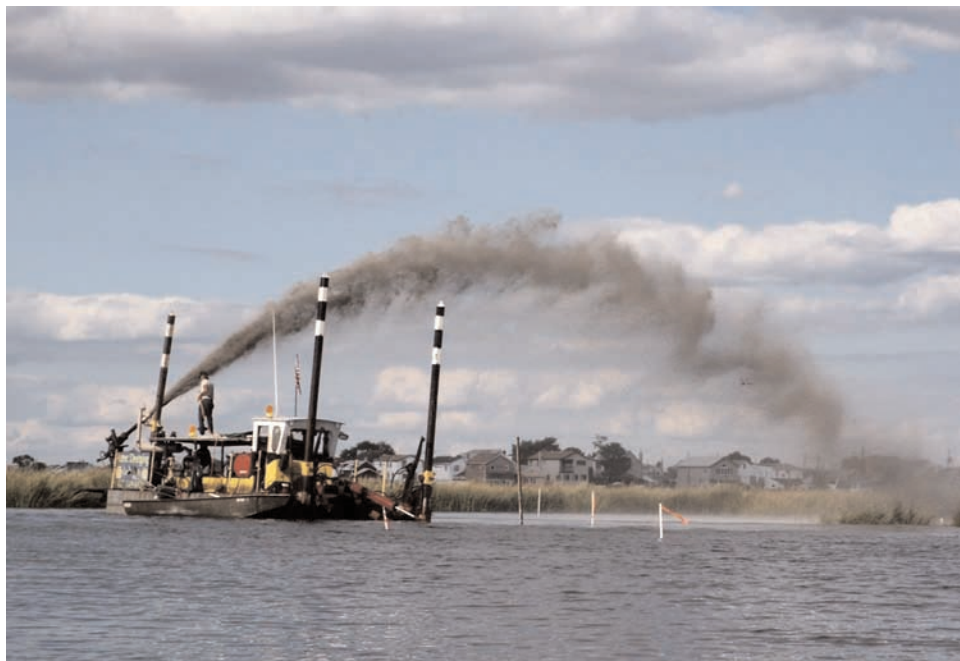
Figure 1. A swing-ladder dredge with high-pressure spray extracted 6,000 cu³ of sand from a trench in the adjacent creek and sprayed it over the surface of Big Egg Marsh.

The selected method for applying sand to the experimental restoration site is by means of a small barge with a swing-ladder dredge and a high-pressure spray (Figure 1). The intake end is the swing ladder, which moves side-to-side across a swath 6.7 m wide with a maximum depth of 1.8 m. The intake pipe has a rotating cutting head at its distal end. The slurry that enters is pumped through a 20-cm diameter pipe, and then reduced to a 10-cm diameter nozzle that sits 3 m above the stern. The slurry spray is supposed to deliver to a distance of around 60 m.

The swing-ladder dredge with high-pressure spray was contracted to pump for 200 hours. During this time, over 6,000 cu³ of sand were placed on the 1-ha treatment site. The spray was effectively delivered to a distance of only 40 m. To gain additional distance, some slurry was streamed farther into the marsh interior by directing the nozzle horizontally across the surface of the fresh fill, causing the slurry to flow further inland. The placement of the fill was guided by white polyvinylchloride (PVC) pipes arranged in a grid pattern. Each pipe contained an elevation target marked with red duct tape and plastic flagging. Dredging was completed by the beginning of October 2003.

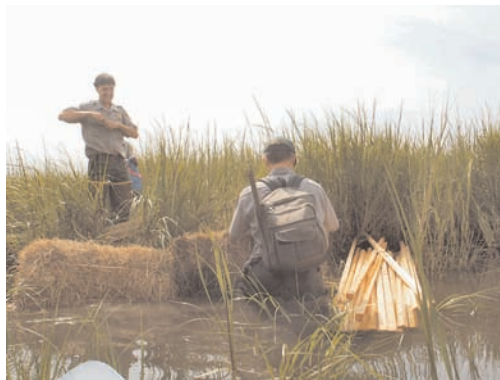
Figure 2. Before spraying sand on the Big Egg Marsh restoration site, 240 hay bales were staked across the drainages to contain the runoff of silt and organics.

Before dredging and spraying sand on the marsh, a silt fence was installed around the low-lying portions of the perimeter. About 240 hay bales, held in place by more than 1,000 wooden stakes and 2,000 m of sisal twine, provided the primary containment (Figure 2). Where silt runoff became apparent, supplemental containment was provided by installing 100 m of black plastic construction fence for silt control.

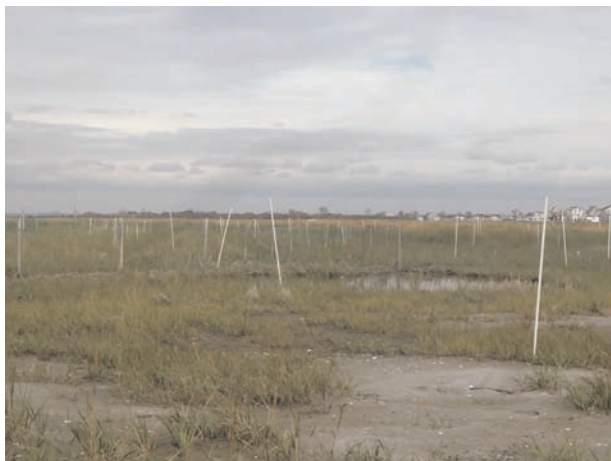
Figure 3. By the end of the first growing season, Big Egg Marsh regained a good carpet of smooth cordgrass (*Spartina alterniflora*). The sandy soil already was accumulating silt, algae, and macroinvertebrates.

The treatment marsh after one full growing season had silt accumulating on the sand. All but the highest places had a cover of algae. The grass was entirely smooth cordgrass (Figure 3). By October 2004, in most of the permanent vegetation plots the stems from seedlings were no longer distinguishable from the stems that arose from rhizomes of the potted plants—their combined density averaged 151 stems/m², with a maximum of nearly 600 stems/sq m. The average stem density was nearly double that of the pretreatment plots and the control plots, due to more of the treatment plots having vegetation in them, i.e., there were fewer bare areas after restoration. The restored marsh already was being colonized by fiddler crabs (*Uca* sp.), eastern mud nassa (*Ilyanassa obsoleta*), common periwinkle (*Littorina littorea*), as well as fishes, worms, and insects.
