# Restoration of the Upper Kawuneeche Valley in Rocky Mountain National Park

## Introduction

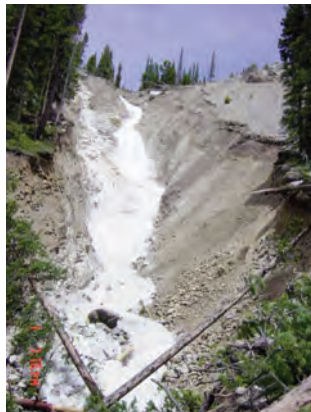
**Figure 2.** Grand Ditch Breach (Zone 1).

The actual cause of the Grand Ditch's failure is uncertain. It may have overtopped or it may have formed a seep that collapsed the ditch sidewall sending about 2.8 m<sup>3</sup>/s (100 ft<sup>3</sup>/s) flow of the ditch down a steep hillside, creating a flood that sent approximately 36,000 m<sup>3</sup> (47,600 yd<sup>3</sup>) of boulders, trees and sediment cascading down into Lulu Creek.

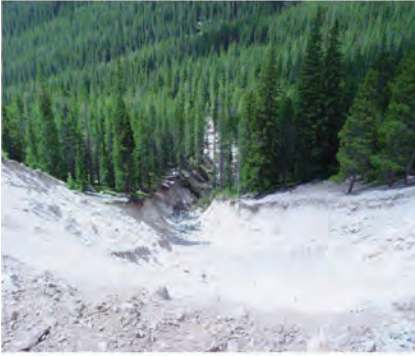
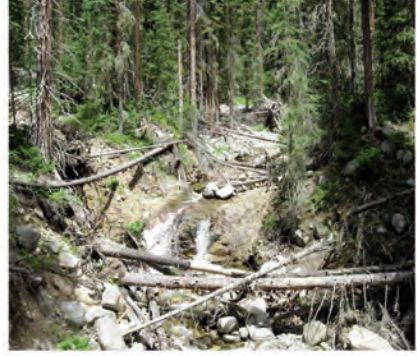
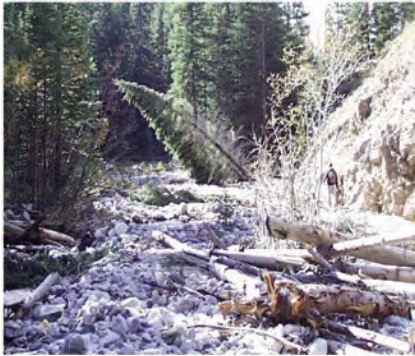
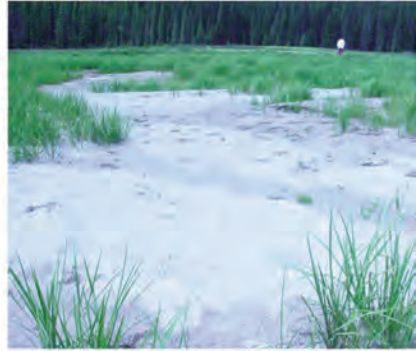
Lulu Creek flowed as a mud- and debris-filled torrent, gouging the streambed up to 2 m deep, widening the channel by as much as 10 times, and uprooting and depositing piles of trees and sediment throughout. When the torrent arrived at the low-gradient confluence with the Colorado River, it deposited sediment and debris in an alluvial fan up to 2 m thick. The sediment-filled waters continued downstream along the Colorado River clogging the channel and covering the floodplain with gravel, sand, and more debris.

About 1.6 km further downstream from the confluence, the flood arrived in the Lulu City wetland where it filled the existing channels and deposited up to 60 cm of silty sand onto the wetland, burying the existing vegetation and altering the wetland's hydrologic regime. Finer sediments were transported an additional 45 km downstream to Shadow Mountain Reservoir, where a visible delta was formed.

**Figure 4.** Breach Impacts, clockwise from top left; Zone 1 (hillside), Zone 2 (Lulu Creek), Zone 4 (Lulu City Wetland), Zone 3 (Colorado River).

Possible restoration options will likely include a mixture of the following, prescribed on a zone-by-zone basis: allowing natural restoration to occur where appropriate; stabilizing steep, unstable slopes with soil nail anchors and metal mesh fabric; using controlled water releases to help reconfigure stream channels; removing deposited sediment and redistributing it through the impacted area; removing downed timber, or using it in the restoration process, or both; re-grading and re-contouring areas to restore proper morphology and function; and native plant restoration with appropriate, locally gathered plant materials.
