22 Ecological restoration in a giant sequoia grove

Background

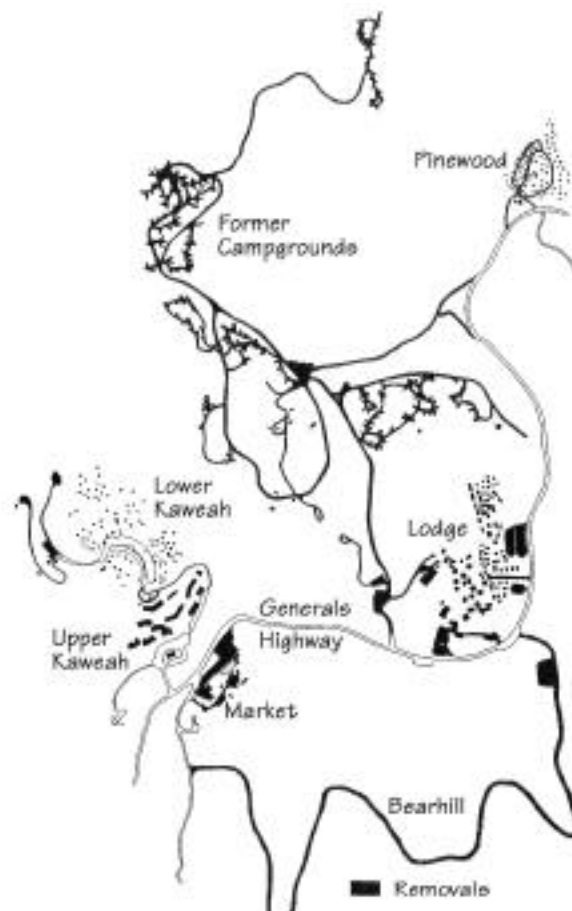
Figure 22.1. Development removed from Giant Forest through 2000 (except Bearhill).

Demolition of facilities. The first objective was to demolish and remove infrastructure without causing further damage. To date, 282 buildings, 24 acres of asphalt, dozens of manholes, and all exposed sewer and water pipe, underground propane tanks, and aerial utility lines have been removed. Demolition will be complete in 2002. The extent of demolition accomplished through 2000 is shown in Figure 22.1.

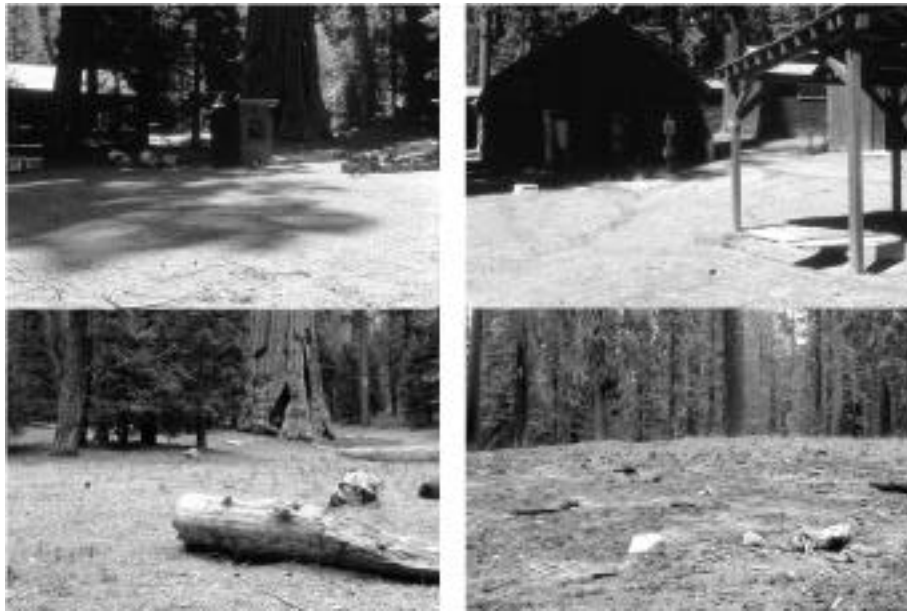
Figure 22.3. Top left: Lodge amphitheater site before restoration. Bottom left: Lodge amphitheater site one year after planting treatment. Top right: Lodge cabin site before restoration. Bottom right: Lodge cabin site one year after burn treatment.

Comparison of plant cover and tree height in planted and burned gaps shows that planting has accelerated vegetative recovery, with significantly greater grass, shrub, and tree cover in planted gaps than in burned gaps (Figure 22.2, bottom). Mean tree height in planted gaps (22 cm) was greater than that in burned gaps (approximately 3 cm), and is approaching mean tree heights in reference gaps (37 cm). Photos taken before and after treatment show woody vegetation visible in planted gaps and not yet visible in burned gaps (Figure 22.3).
