Mr. Lincoln's Neighbors

Historic Preservation/Restoration at the Lincoln Home National Historic Site

Craig Alan Drone

Fischer-Wisnosky Architects, Inc., Springfield, Illinois

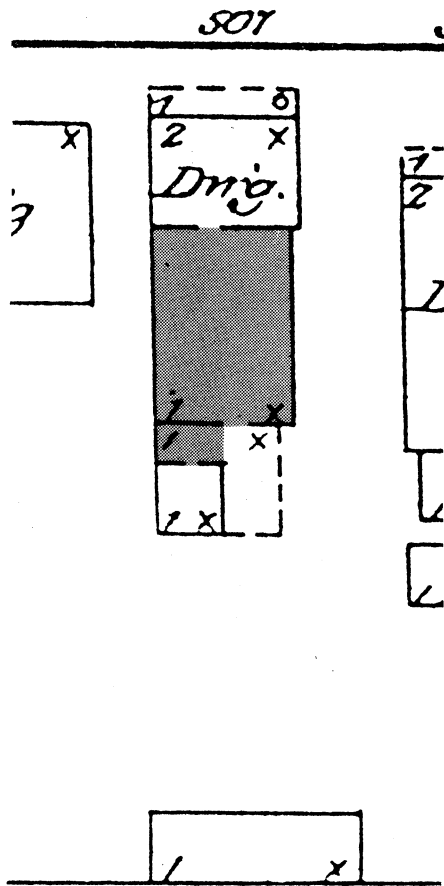
Figure 5. Sprigg House, 1854 & 1884. On the left is a portion of an 1854 city map indicating the simple rectangular plan of the original cottage. The drawing on the right is from the 1884 Sanborn map. The shaded area shows the limits of the original cottage. (Left drawing from *City of Springfield, Sangamon County, Illinois*. Drawn by M. McManus. New York: Hart and Mopather, 1854. Courtesy of Illinois State Historical Library, Springfield. Right drawing from "Springfield, Illinois." New York: Sanborn Map & Publishing Co., February 1884. Courtesy of Lincoln Library, Sangamon Valley Collection, Springfield.)

The Julia Sprigg House (HS-11) was originally built in 1851 as a small rectangular gable-roofed cottage (Figure 5). The 1854 and 1858 city maps indicate a rectangular structure with a porch in one of the rear corners. The house is seen situated toward the middle of the lot. The three panoramic views of the city consistently indicate a structure of similar size; however, these views are not always clear or consistent with the location of the structure on the

lot. The house remained virtually unchanged until circa 1873, when the owner (no longer Julia Sprigg) built a two-story balloon-framed addition with a porch at the front of the house. This plan configuration is indicated on the 1884 Sanborn map. This map further indicates some non-extant outbuildings, one at the alley and one near the immediate rear of the house. This basic configuration remains unchanged until approximately 1922 when a new owner undertook substantial renovations to change the house into a “stacked” duplex. This owner, and another who followed a year later, added a second floor to the rear (or original) portion of the house, lowered by 24 inches the height of the existing second floor, installed all-new Craftsman-style windows and doors, demolished the fireplace, re-sided the original one-story cottage portion of the house (to match the new second floor), and rebuilt the front porch into a two-story brick-columned porch. Some twenty years later, the house was again renovated into apartments and remained that way until the mid-1970s.
